Intel® Celeron® Processor in the 478-Pin Package

Specification Update

June 2006

Document Number: 290749-029

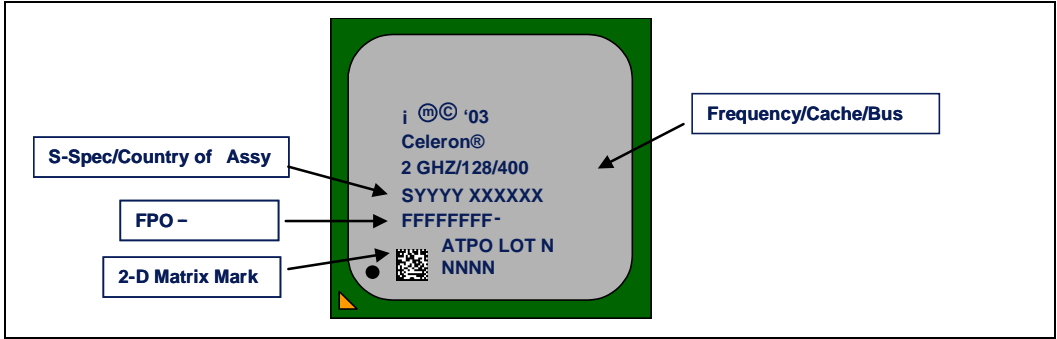
Figure 1. Example Markings for the Intel® Celeron® Processor on 0.13 Micron Process and/or in the 478-Pin Package

This section contains top marking information for the Intel® Celeron® processor in the 478-pin package.
